# DIP Switch Setting Guide

Adjusting Manual Gain Control

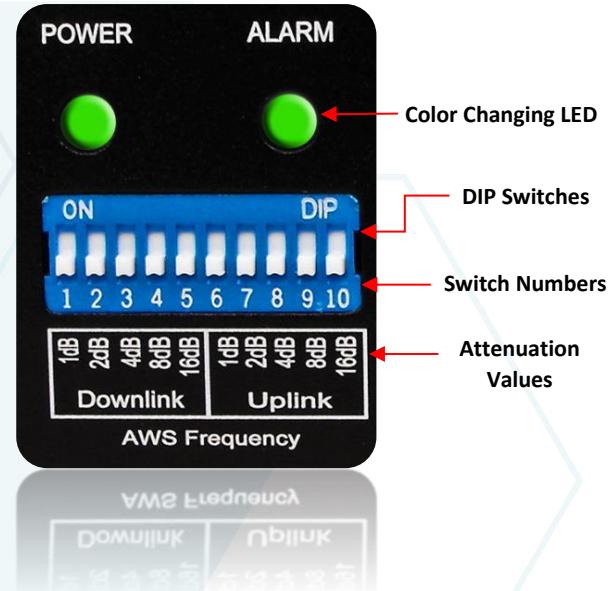
Some repeater systems are also equipped with a pre-amplifier which also has an alarm monitoring feature for the uplink path. The end user should also ensure the alarm LED's on the pre-amp are solid green at all times. If not green, this typically is an indication of another booster nearby that is overdriving the uplink path of the system. **DO NOT** leave the system ON for an extended period of time if this is so as it will eventually cause internal damage to your repeater system. Either try to shut down the interfering booster or relocate the service antenna away from the interference source.

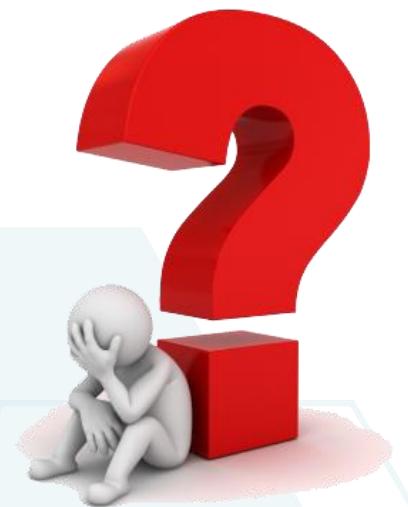
To determine the cause of your alarm LED showing an error, you can disconnect the indoor antenna / service line from the “INDOOR” port of the repeater. If the LED does not change to green, then it's either a case of the input signal after passing through the pre-amp is now too strong or there is another antenna within a few feet of your donor antenna that's causing the interference. If there are no other antennas close by, at this point you must attenuate the downlink DIP switches by 2dB increments till the LEDs turn green again. (**Switches 1-5**) After this, you must match the same attenuation value on the uplink side (**Switches 6-10**). Once complete, please reconnect the indoor antenna / service line again. If after connecting the indoor service line the alarm LED changes back to amber or red then signal oscillation is taking place.

SYSTEM IN ALARM! WHY?

Signal oscillation (OSC) is the result of your indoor and outdoor antennas being too close to each other and should be separated more or oriented away from the donor antenna. If you have confirmed your donor and service antenna placements are in optimal locations and the repeater is still in alarm, you then need to add more attenuation by 2dB increments till the LED's turn green again. Remember to rematch the uplink value to the downlink.
